McKinley Beach Safety Study

Milwaukee, WI

Milwaukee County

April 21, 2022

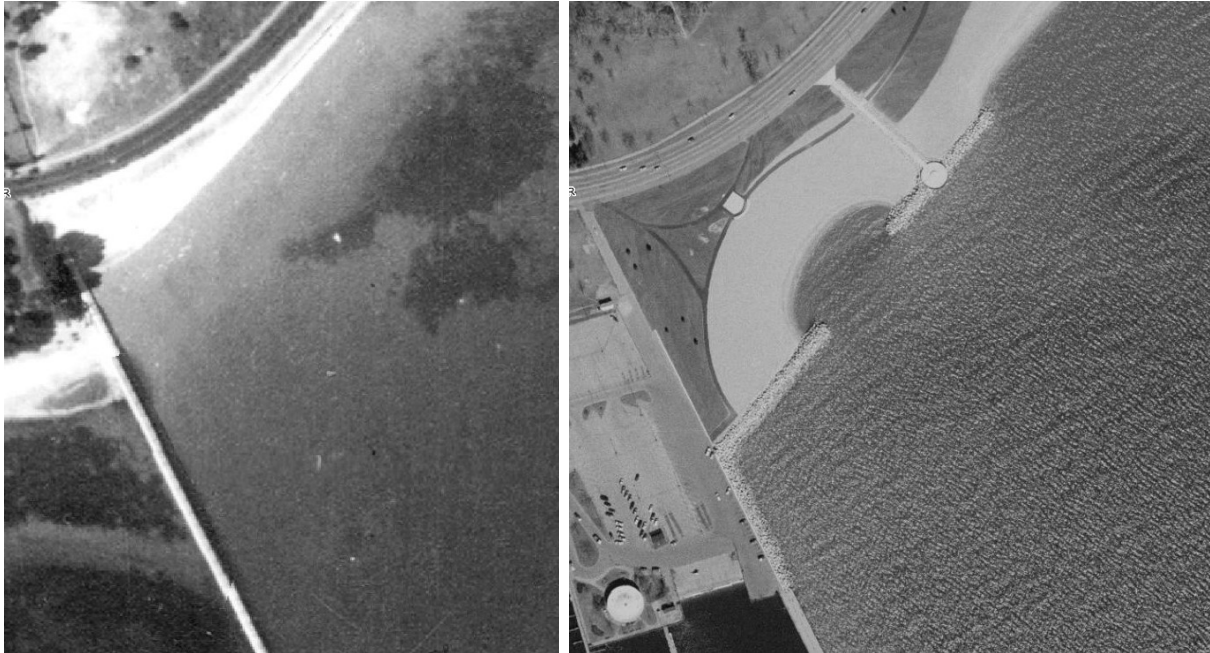
Figure 1 – McKinley Beach 1937 and 1989 (Milwaukee County Land Information Office)

Figure 1, below, shows McKinley Beach in 1937, the earliest available aerial imagery, and 1990, the first aerial imagery of the then newly designed pocket beach configuration, which remains today.

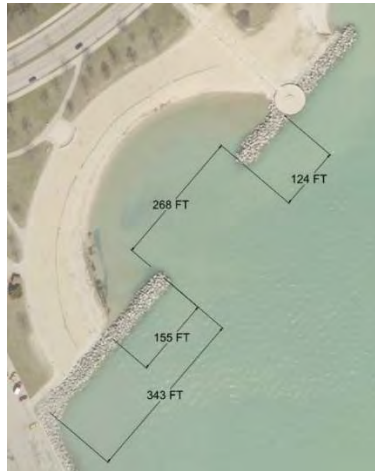
Figure 6 – McKinley Beach Dimensioned (2020 Aerial Photography Milwaukee County)

The beach and swim pocket appear to be in relatively good condition with little to no apparent incidents of stormwater beach scour. At time of study – the greatest width of the swim pocket was 547' from waters edge to waters edge and approximately 223' in the transverse direction from the breakwaters to the shore. During field visits algae and other bio-organic matter is often seen in the northeast corner of the beach.

Despite extreme high water in 2020 and varying water levels in the three decades since its construction, McKinley Beach has held up fairly well from a sustainability standpoint. Referencing the original plans, found in Appenix B, and assuming the relative 0' elevation to be approximately, 580.87' on a comparative datum the beach appears to have lost about 0.87' or 10.5" of sand to erosion or currents.

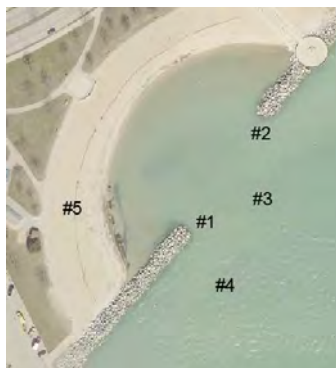
Figure 7 – Sediment Grab Sample Locations

Sediment grab samples were collected to perform grain size analysis from the locations shown below:

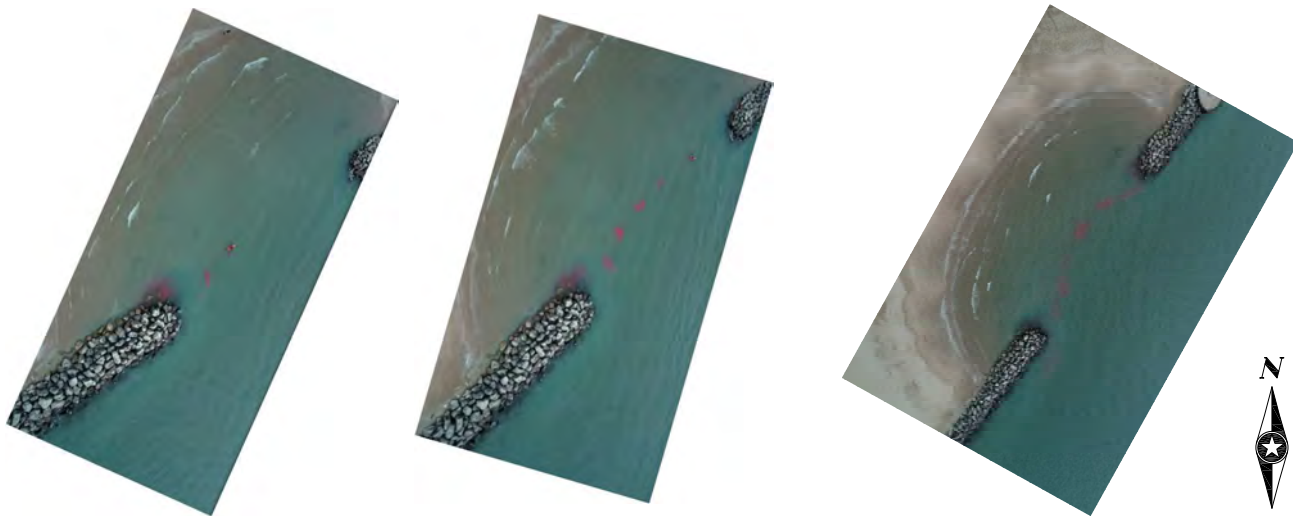
Figure 17 – Wave Data from the 12 Hour Lead-Up

Lakeward¹¹ dispersion of the dye is observed from the north end of the south breakwater. Methodology was modified to hold the drone in a static position for future tests.

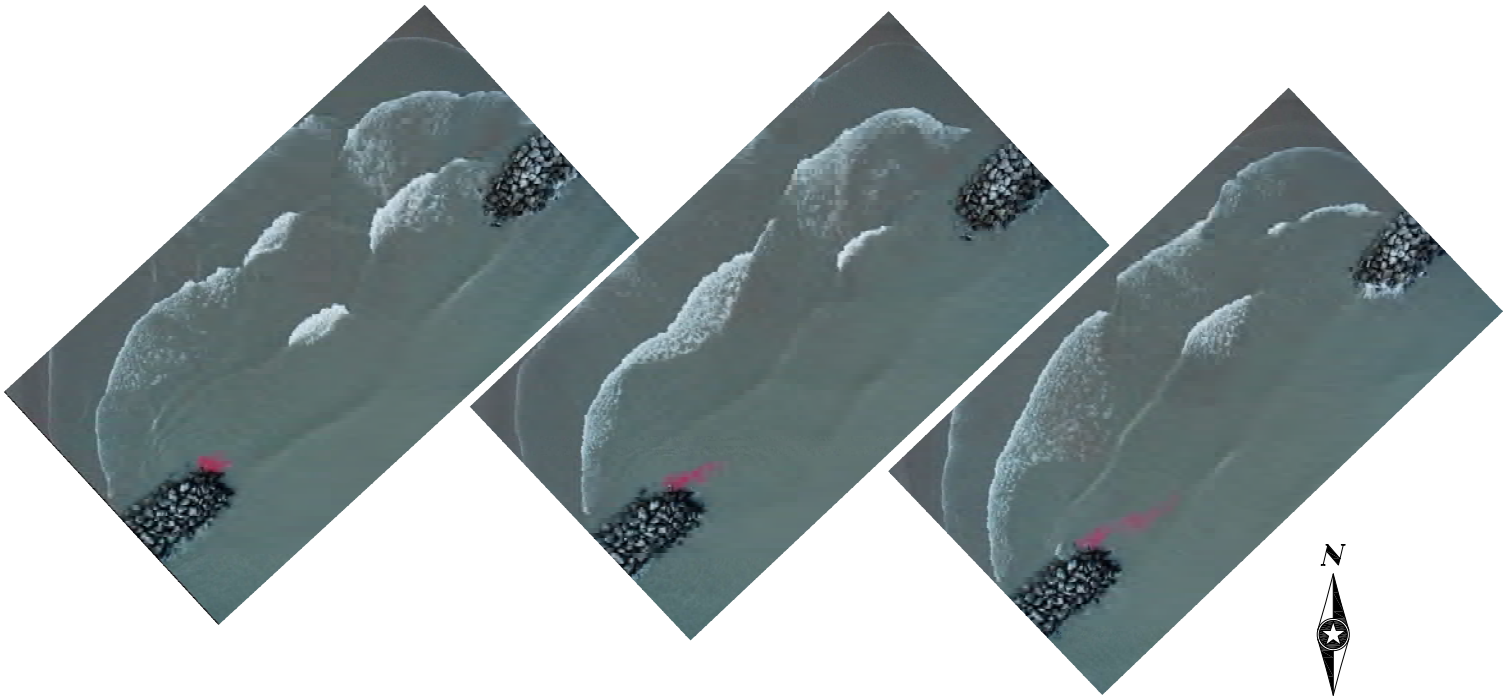
Figure 21 – Wave Data from the 12-Hour Leadup

The dye front is moving from southwest to northeast at speed of approximately 1.76 ft/s despite significant wave energy to the contrary. A current of roughly 2 ft/s in a wave that is 2 ft tall is generally accepted to challenge an inexperienced swimmer. This current activity was replicated in the hydrodynamic modeling.

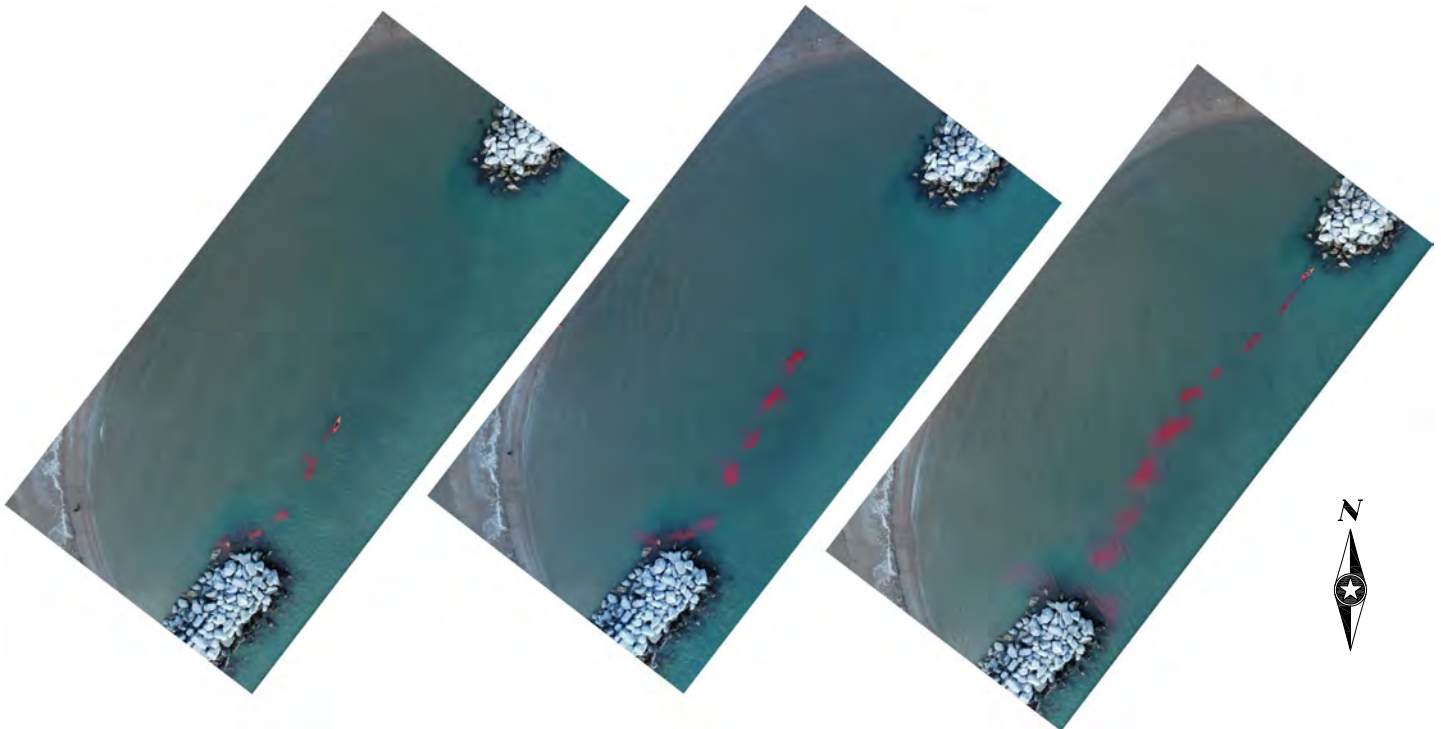
Figure 23 - Wave Data from the 12-Hour Leadup

Dispersion from the north end of the south breakwater was observed.

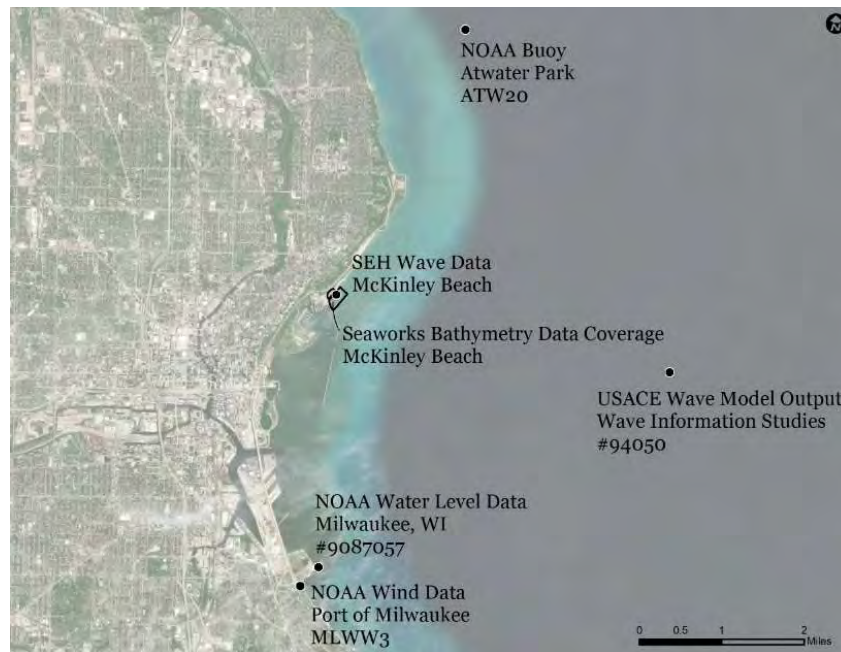
A bathymetric digital elevation model was developed based on survey data from Seaworks obtained in 2021. Water level inputs were developed from the nearby NOAA gage #9087057 (Milwaukee, WI). Wind data were developed from the nearby NOAA buoys MLWW3 (Port of Milwaukee) and ATW20 (Atwater Park, WI). Wave conditions were developed from USACE Wave Information Study (WIS) output at Station #94050 and from NOAA buoy ATW20. The map below illustrates locations of key datasets.

Figure 25 – Key Observed Data Locations Supporting the Wave Model

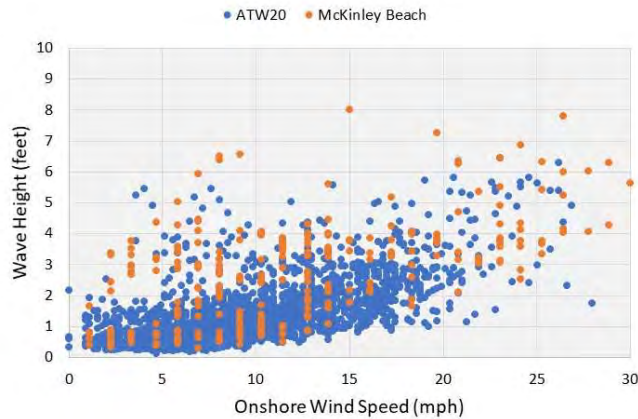
Figure 26 – Correlation Wave Data ATW20 and Spotter Buoy

For wind conditions that are similar to those that preceded the drownings, the McKinley Beach buoy registers similar wave heights to the ATW20 offshore buoy. This confirms the adequacy of using the ATW20 buoy to represent conditions during the 2020 drownings. Figure 27 displays a substantial portion of the record of data at the Spotter Buoy. Vertical dashed lines represent periods when onshore wind speeds are nearly 12 miles per hour. Wind speeds of this magnitude preceded the drownings, and wave heights at ATW3 were approximately two feet. Site data are also approximately two feet when onshore wind speeds approach 12 miles per hour, indicating that wave observations at the offshore buoy (ATW20) can be a good proxy for wave conditions near the site.

The primary wave data source (NOAA station ATW20) represents offshore conditions approximately 3.5 miles northeast of the site, so it was important to confirm whether wave conditions closer to the site are similar. The confirmation was done by evaluating whether the McKinley Beach buoy data collected by SEH from November 2021 through mid-January 2022 are consistent with wave data at the ATW20 offshore buoy, specifically for the type of wind conditions preceding the drownings. The ATW20 offshore buoy was retrieved before November 2021 so the data periods do not overlap and a direct comparison is not possible.

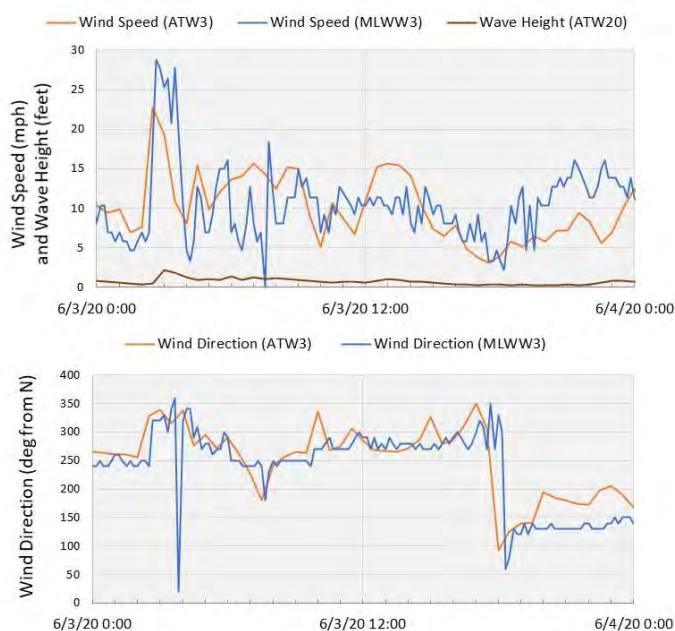
The model simulation with waves at a 190-degree angle (out of the south) are considered most representative of this event (Figure 29 below).

Figure 29 - June 3, 2020 Wind and Wave Conditions at Two Stations near McKinley Beach

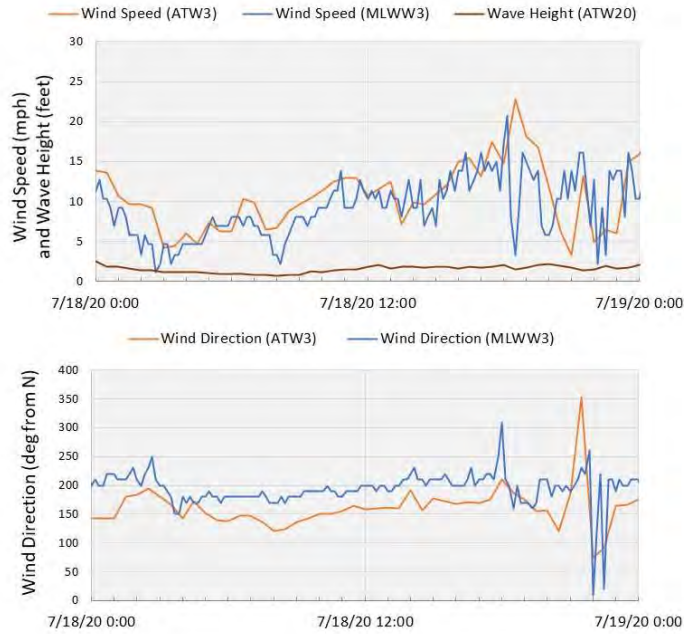
The model simulation with waves at a 160-degree angle (out of the southeast) are considered most representative of this event (Figure 30 below).

Figure 30 - July 18, 2020 Wind Conditions and Similar Conditions from WIS Record

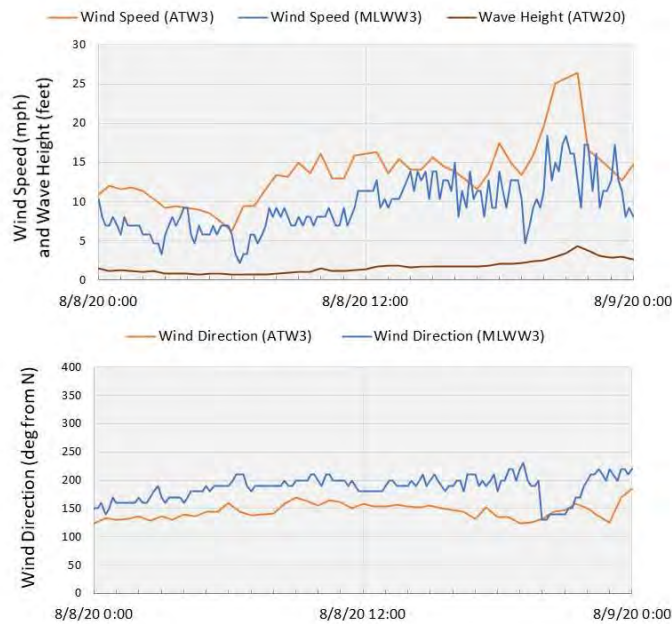
The model simulation with waves at a 160-degree angle (out of the southeast) are considered most representative of this event (Figure 31 below).

Figure 31 - August 8, 2020 Wind Conditions and Similar Conditions from WIS Record

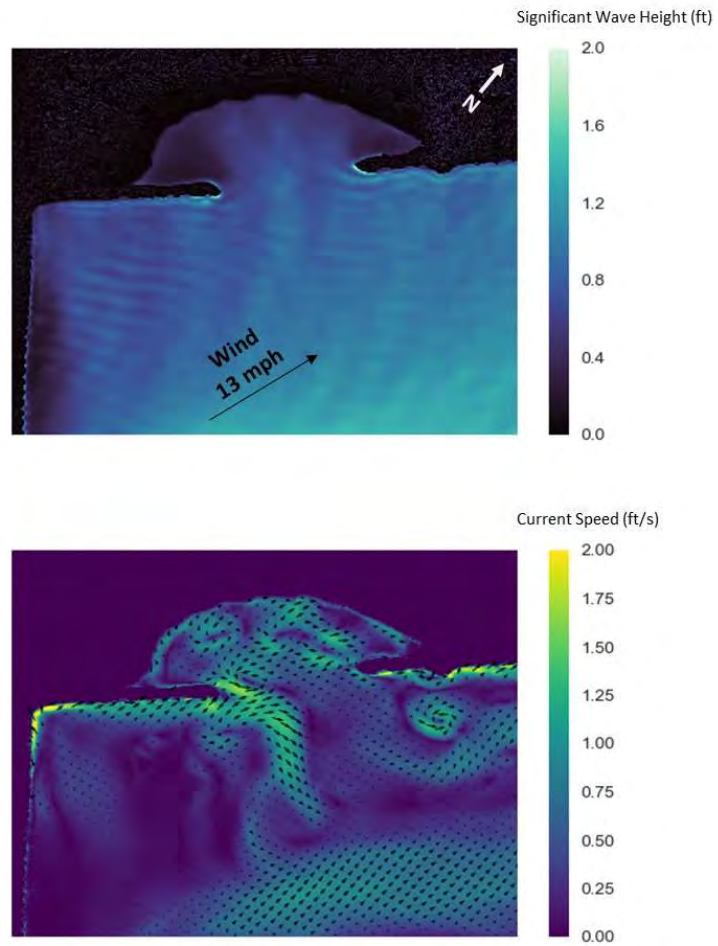
Results from the four directional wave simulations are illustrated below. As noted above, two of these conditions—the 130- and 160-degree direction conditions—are good proxies for the three drowning events. Each simulation yielded a current pulling away from the south end of the south breakwater.

Figure 32 - Simulated Wave Heights and Current Speeds, 2-foot Waves, 190-deg direction (out of south) as indicated by the black arrow. Proxy for the June 3 event

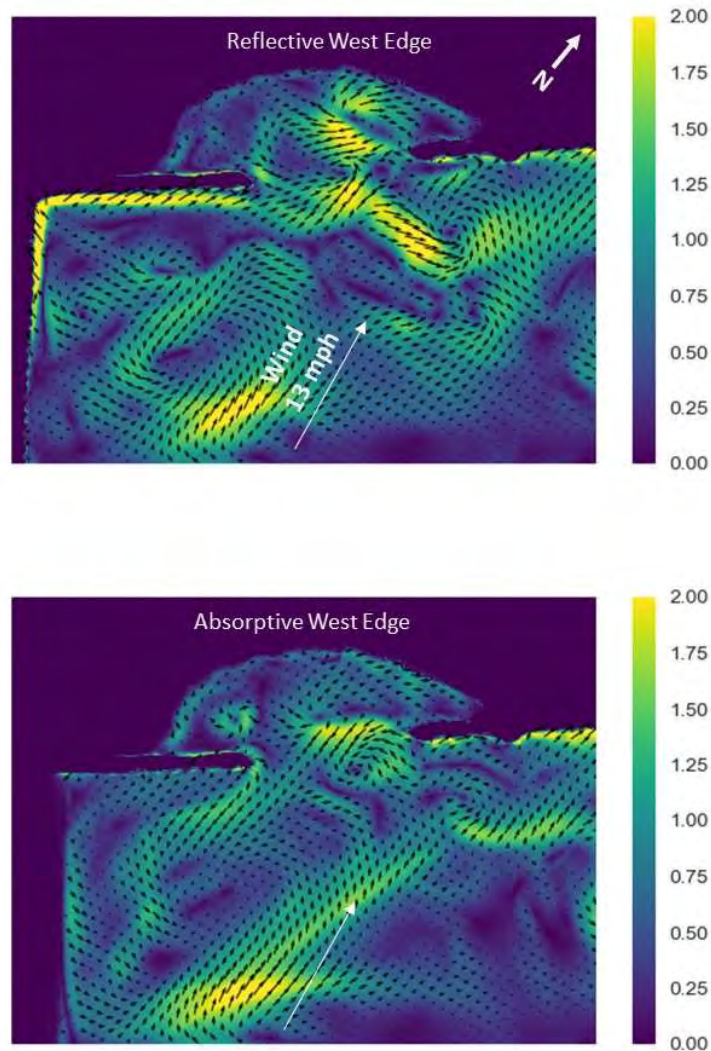
energy at the seawall rather than reflecting wave energy. This simulation is useful for evaluating the degree to which wave reflection off the seawall effects currents at McKinley Beach. The simulation showed some reduction in current speeds in the McKinley Beach swim area relative to the more realistic reflective condition, but the effect was only moderately significant and a solution involving “softening” the seawall, which can actually be done through adding roughness may not pass a cost-benefit analysis.

Figure 36 – Model Analysis of the Effect of an Absorptive (Roughened) West Edge (Government Pier)

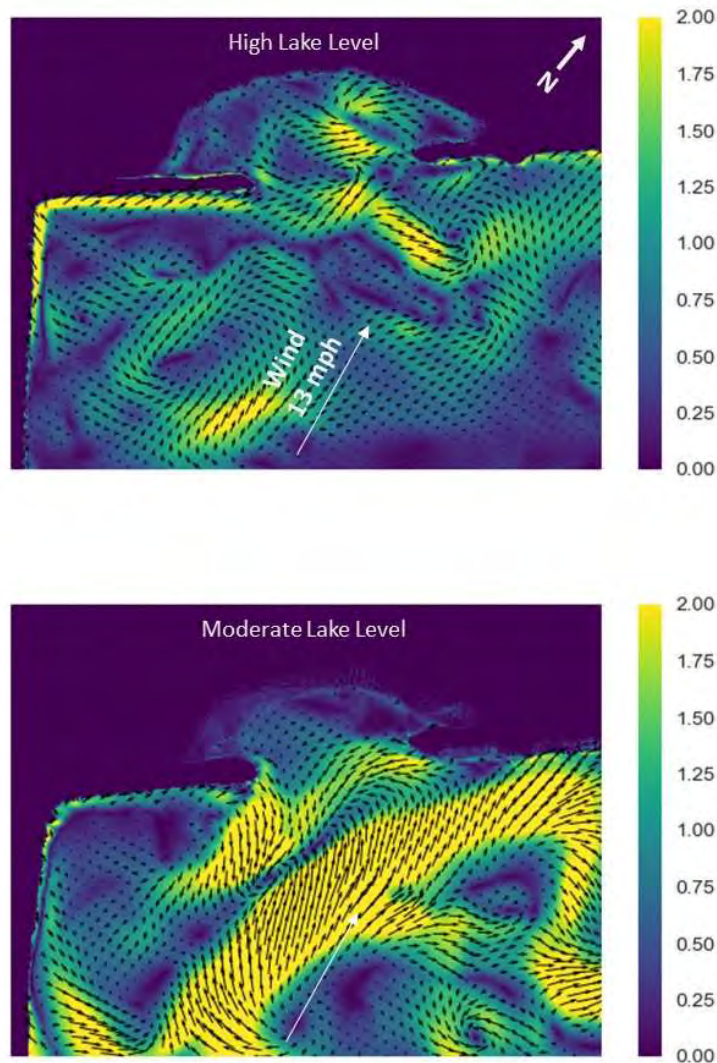
Another test simulation indicates that recent high water contributed significantly to the presence of rip currents at McKinley Beach. For this simulation, modeled water levels were reduced from 582.5 feet (high water level conditions during summer 2020) 579.2 feet (a moderate lake level). Predicted swim area currents for the moderate lake level condition are appreciably lower and are illustrated in Figure 37 below. During lower lake level conditions, wave energy dissipates farther offshore than during high water conditions. This helps explain the large difference in current speeds within the swim area for the two simulated lake level conditions.

Figure 37 – Model Analysis of the Effect of a High Water Condition and a Moderate Water Level Condition

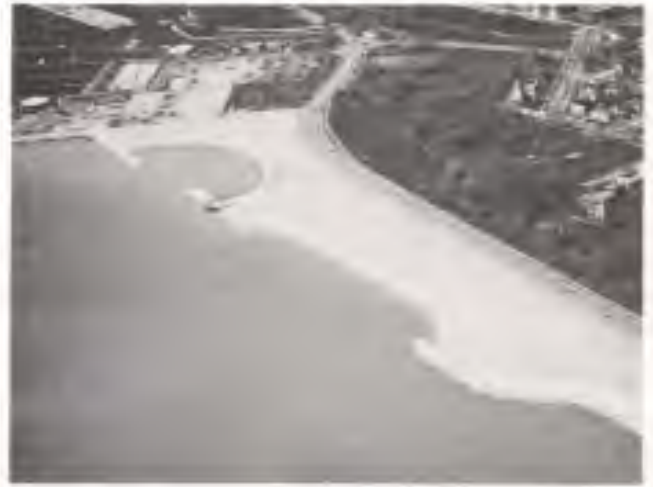
Figure 110

TYPICAL ARMORED HEADLAND AND POCKET BEACH SYSTEM

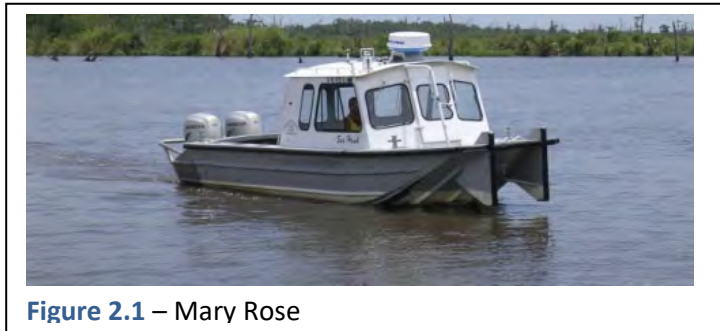
The Z-Boat 1800-RP is a small, remote-controlled, “drone” survey vessel capable that can be equipped with most of the same survey technologies as Seaworks’ large survey vessels. It’s portability and compact size make it ideal for shallow-water surveying, difficult to access areas, and protected waters of any depth. Seaworks’ boat has a “ruggedized package” upgrade which features a single lifting eye, a dual- GPS/GNSS antenna mount frame, and an interchangeable sensor mount well.

- Length: 6’
- Width: 3’
- Height: 3’
- Survey/max speed: 3/8kts
- Boat weight: 85lbs
- Payload capacity: 65lbs

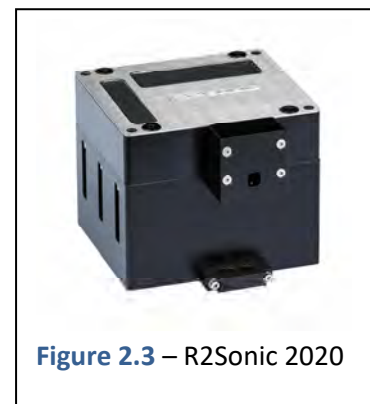
Sonar Equipment & Accessories

- Multibeam Echosounder: R2Sonic 2020
- SV Profiler: Teledyne Odom Digibar Pro
- Sonar Head SV: AML MicroX Sensor

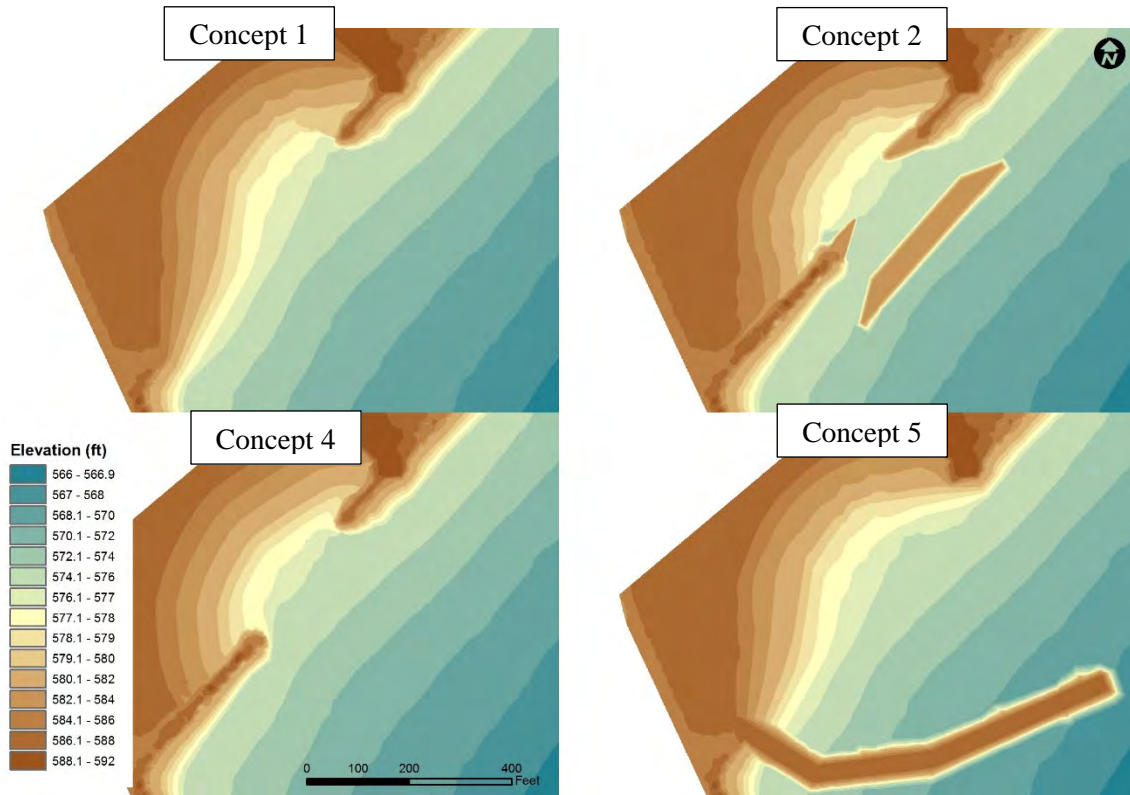
Figure 10: Elevation Conditions Representing Concepts 1, 2, 4, and 5

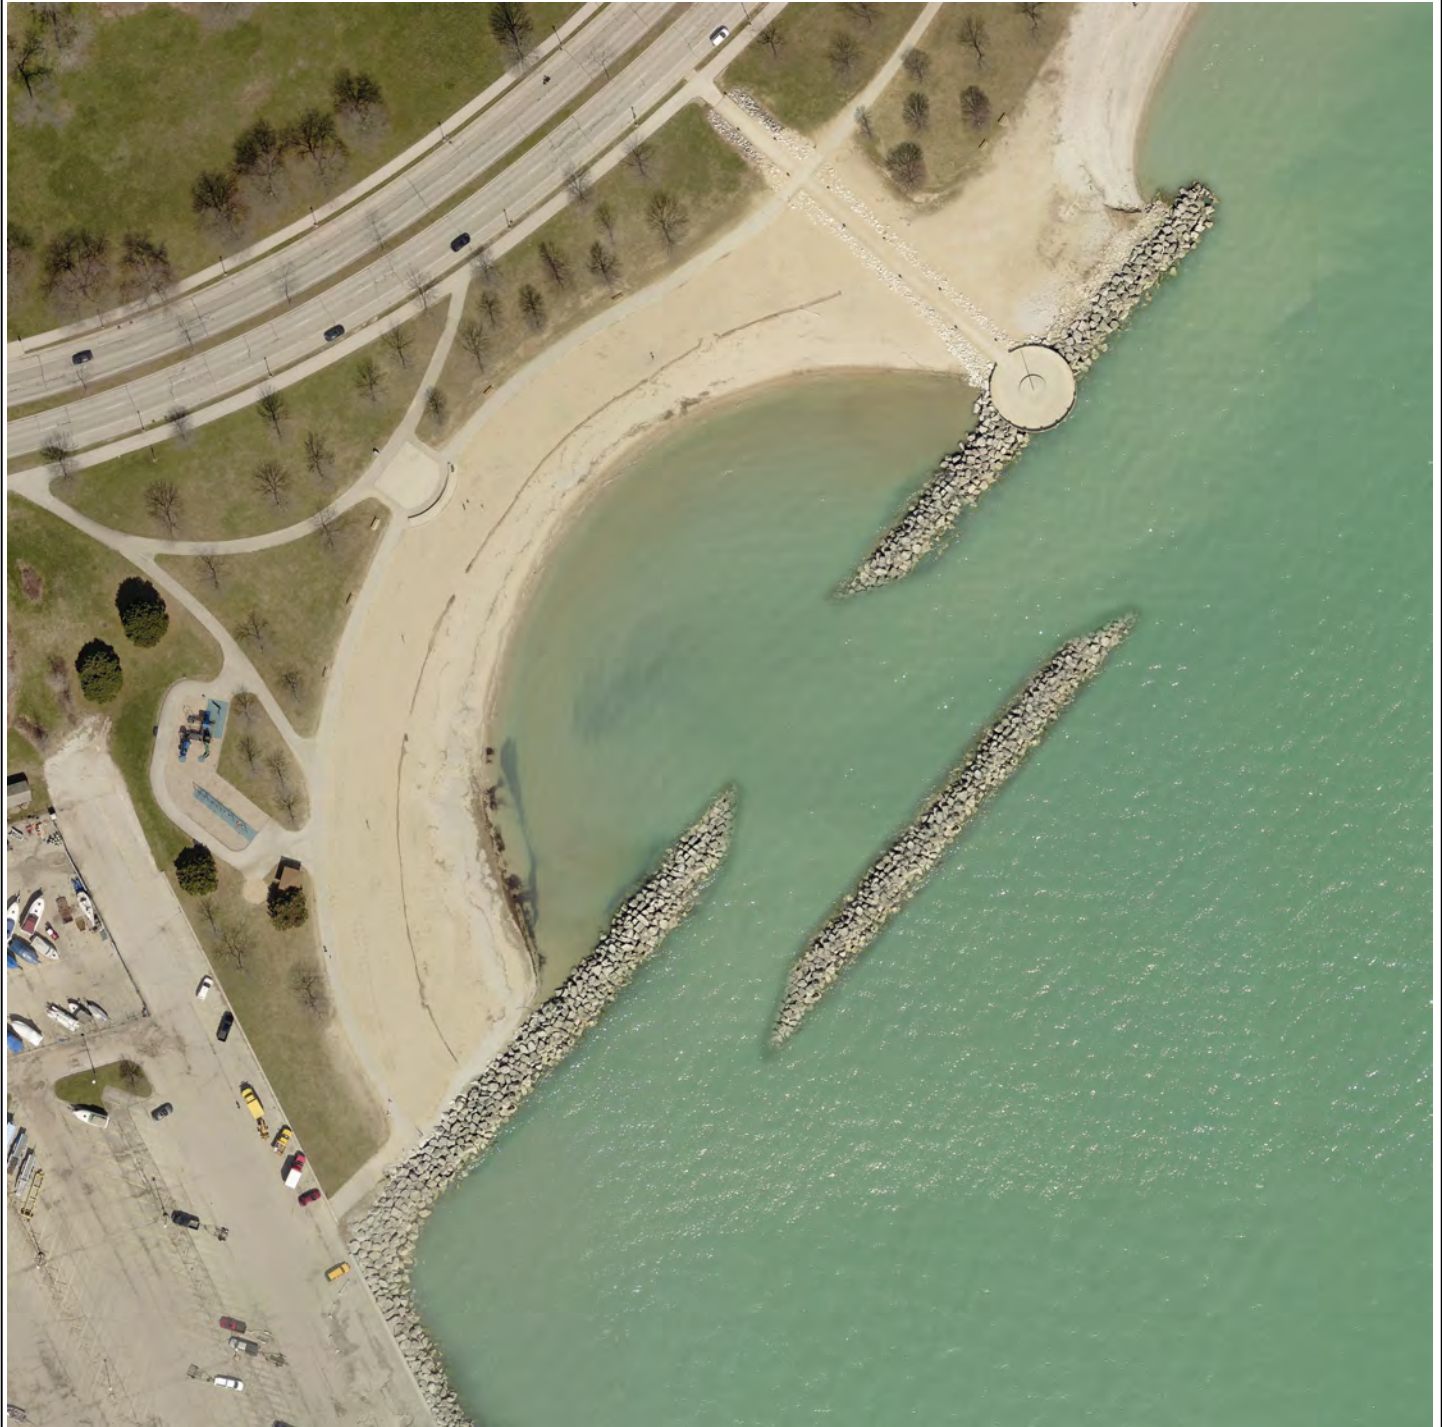
Exhibit
7

Conceptual Solution #1
Enhanced Schematic Design

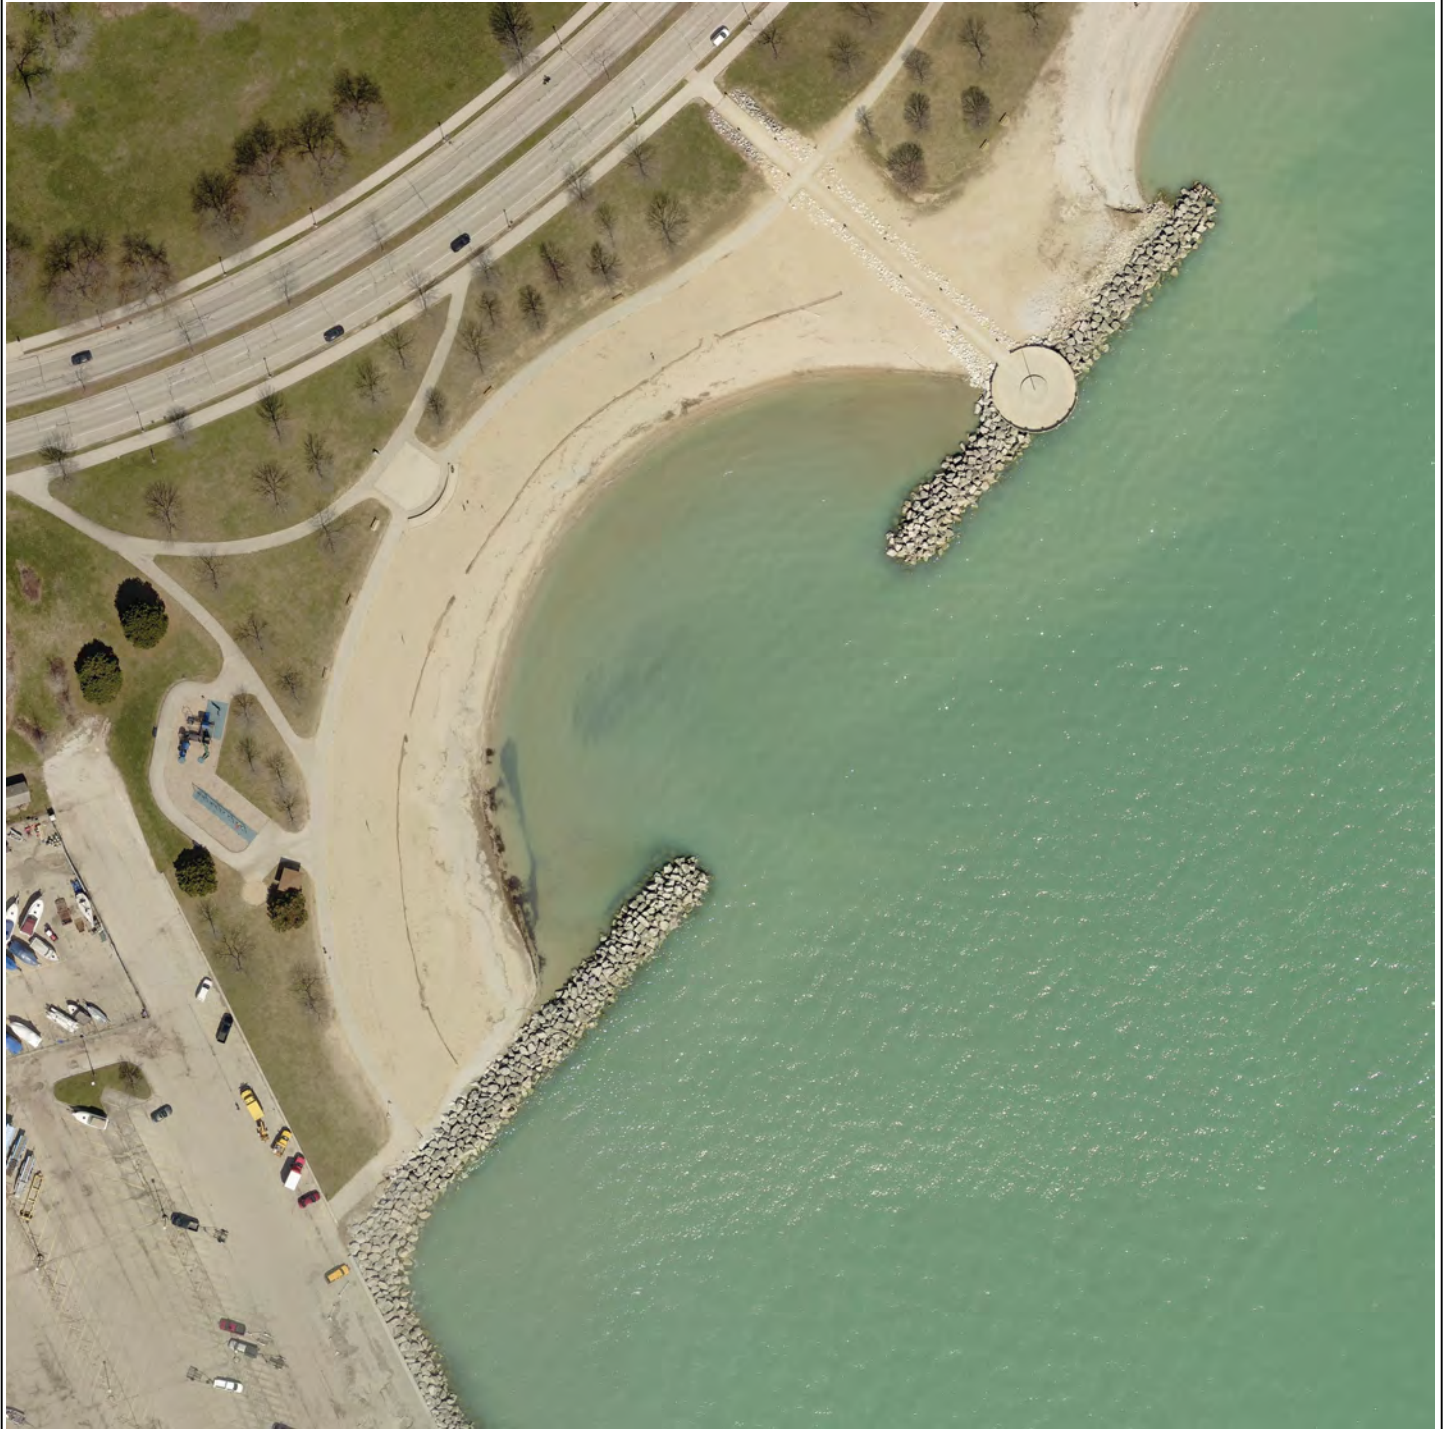
Exhibit
9

Conceptual Solution #3
Enhanced Schematic Design
