# **Mitchell Park Horticultural Conservatory – 2016 Update on Costs and Options for Domes**

**P490-15654-4**

**November 10, 2016**

**Milwaukee County  
Architecture, Engineering &  
Environmental Services**

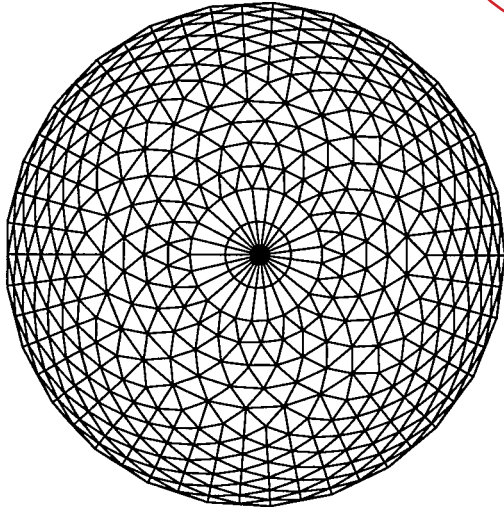
PLAN

FINISH: 70% PVDF Std. Color (2 Coat)  
(Non-Exotic, Non-Metallic, Non-Bright White)  
FLASHING: 18 GA Aluminum  
SLOPING GLASS: 1-1/4" Ins.: 1/4" VE1-2M Clr. H.S.  
w/ Low E(2); 1/2" A.S.; 1/2" Clr. H.S. Lam.  
w/ .030" Clr. PVB  
VERTICAL GLASS: -----  
-----

Cost estimate is for one dome.
